Technische Mitteilung/Service Bulletin AT01-018

Nachrüstung eines Kantenschutzes am Hauptfahrwerk ***Retrofit of a edge protection for the Main Landing Gear***

ATA-Chapter 32-10:
 Introduction of a aerodynamically shaped edge-
 protection for the main landing gear legs.

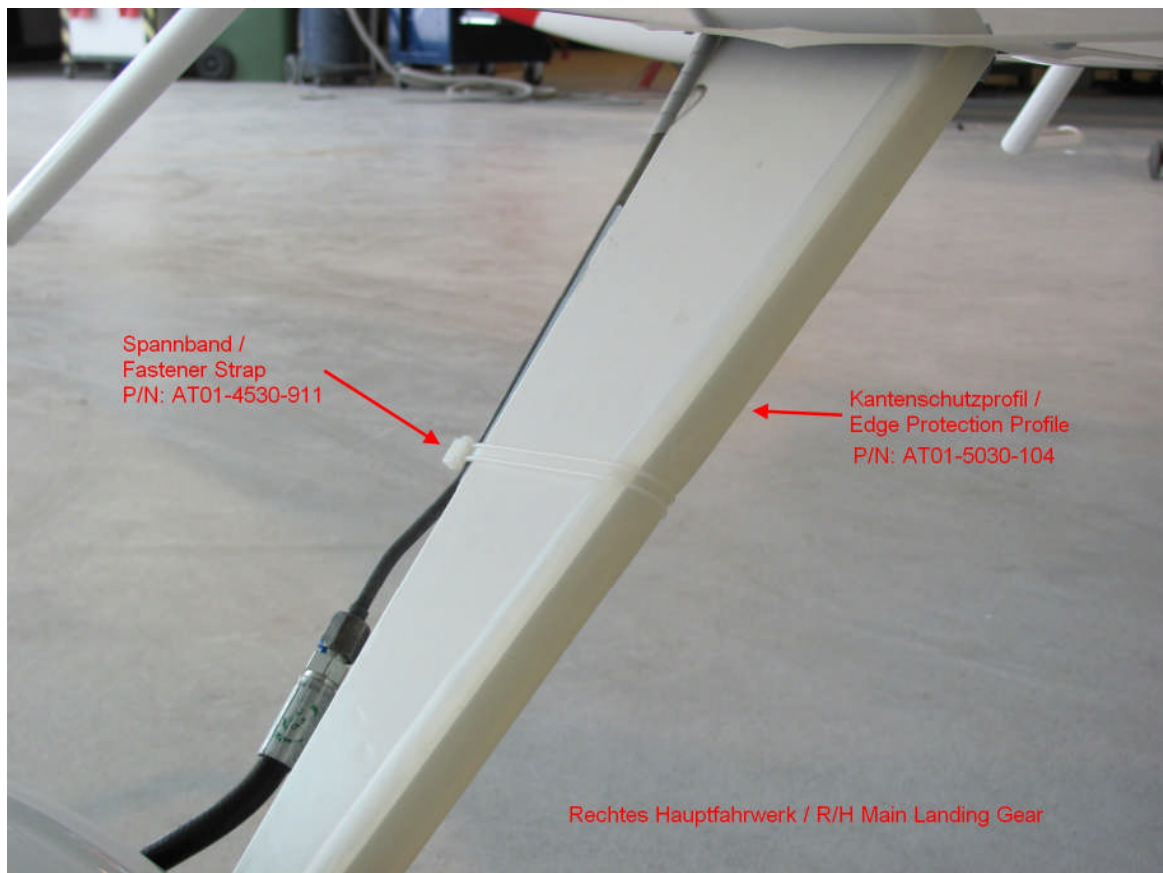
Installation

During maintenance events it was observed
 that some main landing gear legs are
 damaged by stone-chipping.

- Cleaning of the main landing gear legs: front area and side areas (min. 2cm / 0.8 in.)
- Repair/Sealing of damaged areas on the main landing gear legs (see work instruction)
- trimming of the protection profile
- Gluing of the profile onto the main landing gear legs

- Sanding of damaged areas (grit 400)
- Cleaning of damaged areas with alcohol
- Priming with 2-component-Epoxy-Primer (automotive market)
- sealing with white (RAL 9016) paint (i.e. repair kit from the automotive market)
